Technical Report 553

**WORK SYSTEMS PACKAGE/PONTOON
IMPLACEMENT VEHICLE OPERATIONAL
TESTING AT SAN CLEMENTE ISLAND, 1979**

**Demonstration of a technology for remotely
controlled deep-water recovery of objects
up to 5 tons from depths to 20,000 ft**

**RL Wernli
6 June 1980**

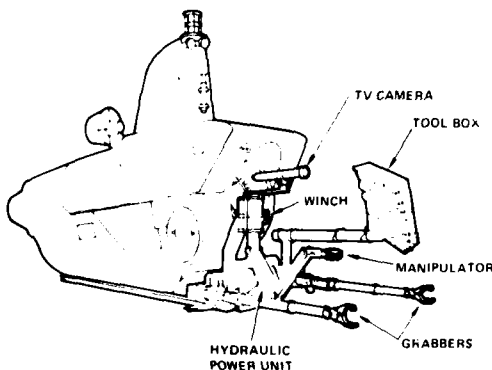
The Work Systems Package (Figure 1) was chosen as a representative system to demonstrate work capabilities required for deep water recovery and work operations. The WSP was developed and fabricated under the Navy's Deep Ocean Technology Program and is designed to provide a versatile work capability to depths of 20,000 feet. The WSP is a group of manipulator arms and tools integrated into a modular package that will provide a heavy-duty work capability when mounted as a unit on unmanned cable-controlled submersible vehicles, as well as on manned vehicles. In addition, it can be positioned and controlled by divers or operated independently from a surface support ship for operations at shallow depths without the need for a submersible. The system was designed to accomplish a complete work task on the ocean floor without the necessity of resurfacing for tool interchange. Basic components of the work package include two simple outer manipulator arms, without elbow functions, that act as "grabbers" or restraining/holding arms to steady the vehicle or to hold small work pieces. A centrally located seven-function manipulator arm can select, interchange, and operate a variety of hydraulically-powered, explosively-actuated, or electrically-actuated tools. Included in the tool storage box are

Figure 1. WSP on Alvin.

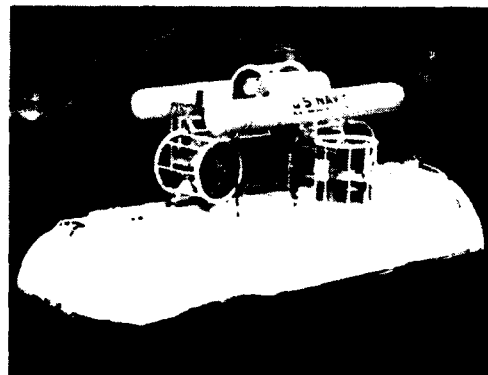
The Pontoon Implacement Vehicle (Figure 2) was chosen as the mounting platform for the WSP. The PIV was developed as a part of the Large Object Salvage System (LOSS) at the Naval Coastal Systems Center, Panama City, Florida. The PIV is a cable-controlled, highly maneuverable, and precisely controllable vehicle. The PIV is powered through a system of five variable-speed thrusters, providing three-dimensional motion. A variable ballast system, carrying a load of sea water up to 2,000 pounds, can be used in conjunction with thrusters to provide the lifting force. A television camera and light source are mounted on each of two pan and tilt units to assist in flying and positioning of the vehicle for salvage or recovery operations.

Figure 2. Pontoon Implacement Vehicle.
(LRO 47059-3)

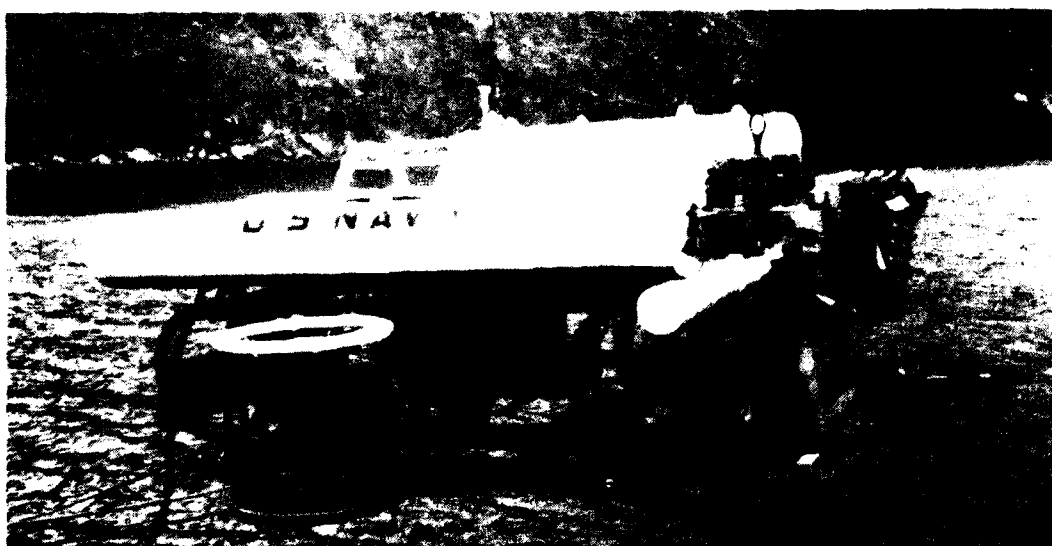
The Work System Package (WSP) was mated with the Pontoon Implacement Vehicle (PIV) (Figure 3) and transferred to San Clemente Island (SCI) for testing on 17 July 1979. SCI had been chosen as the test site because of the clarity and depth of the water and the protection provided by the NOTS Pier area (Figure 4). Operations were conducted off the YD197, a NOSC crane barge (Figure 5). This provided WSP personnel with adequate deck space and support facilities along with a crane capable of launching and recovering the approximately 28,000 pound vehicle. The vehicle was released from the YD197 crane by divers once it was in the water.

Figure 3. Work System Package mated with Pontoon Implacement Vehicle.
(LRO 3544-8-79B)

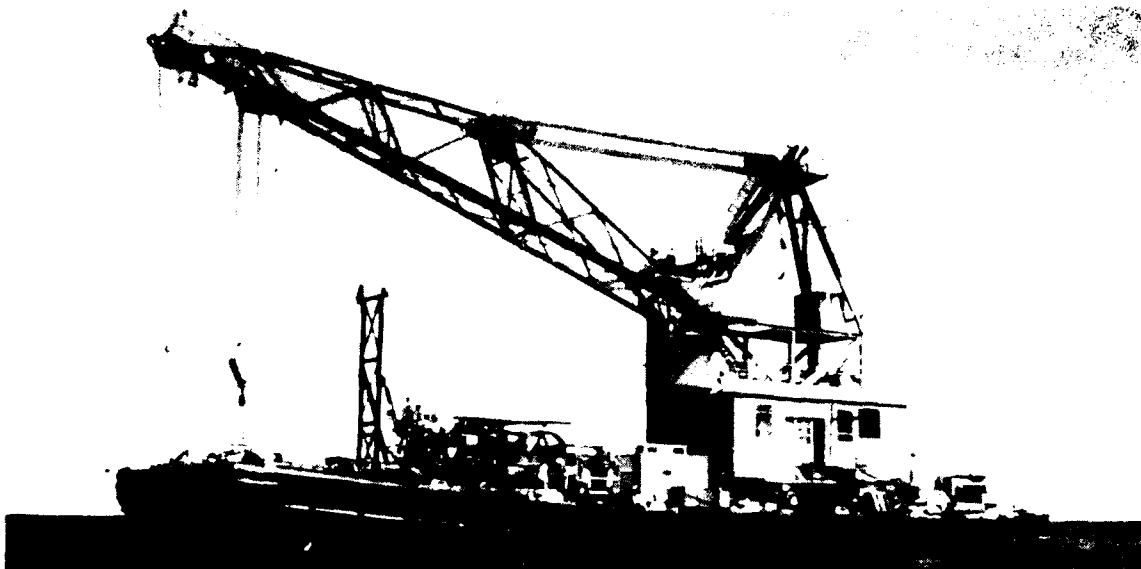
Figure 5. YD197 with WSP/PIV on deck.
(LRO 4305-9-79B)

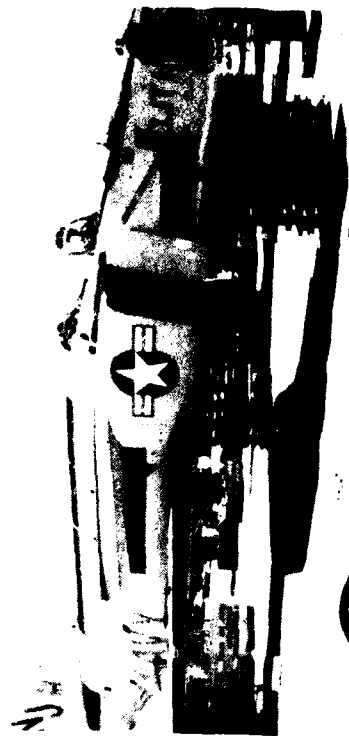
Figure 10. F4 (LRO 3143-79A)

- a. Flat Plate — Approximately 8 feet x 8 feet, 1/2-inch thick steel. This provided a heavy, thick, large drag object capable of accepting simple attachments.
- b. Large Appendaged Object — A larger, heavier object that would allow use of both simple or complex methods of attaching/rigging on or off the bottom was desired. The "old WSP test fixture" was used for this object. It is approximately a 5 feet x 7 feet open steel cube. Approximate weight is 2,400 pounds (Figure 7).
- c. Jet engine (Figure 8).
- d. Wing section (Figure 9).
- e. Aircraft — F4 and E1B (Figures 9 and 10).

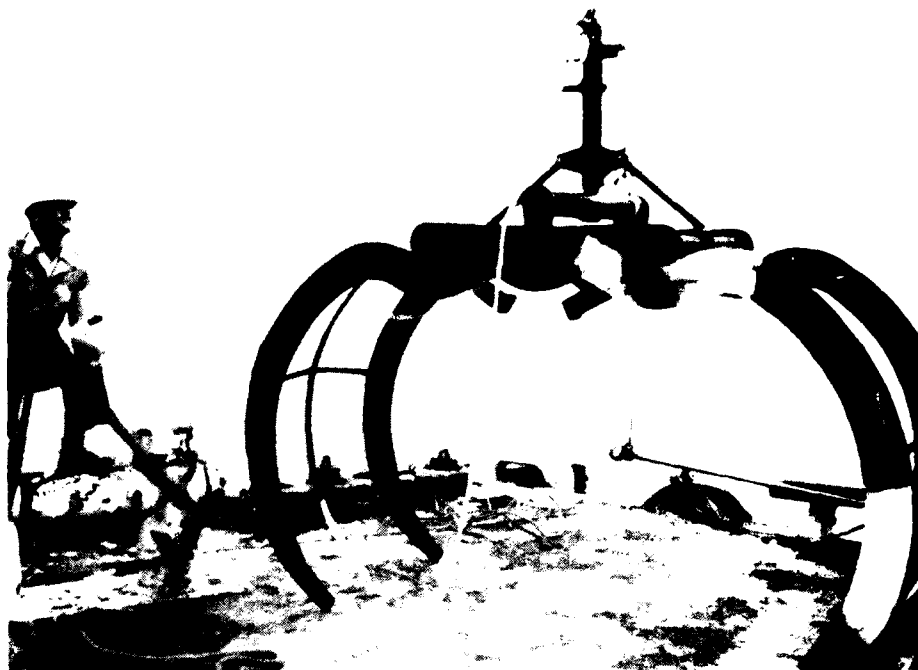
Claw — The claw assembly (Figure 11) provides grasping similar to that used for torpedo recovery and was used during SCI testing to provide an attachment point for the lifting of a jet engine. This test was designed to provide data on attachment/lift feasibility for aircraft components under 2,000 pounds. The claw assembly was borrowed from the Submarine Development Group 1 for use in the SCI testing.

Figure 11. Claw assembly (approximately 5-foot wide opening).
(LRO 3430-8-79B)

A successful lift of a jet engine was conducted using the claw assembly as the attachment point. Deficiencies with the original claw design were experienced but did not severely hamper operations.

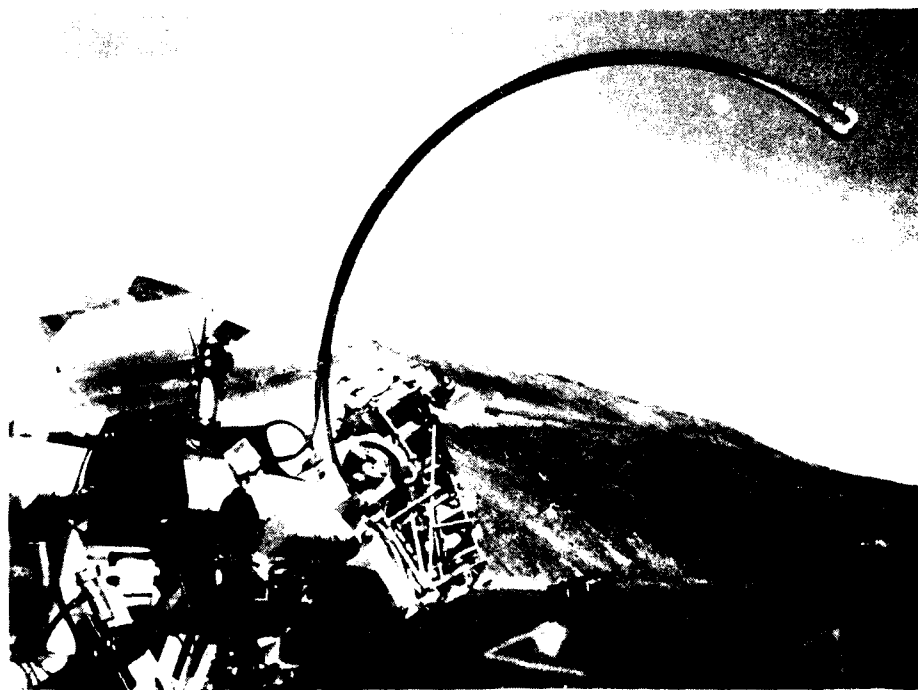
Sling — The lift sling emplacement device (Figure 12) was developed to provide a lift method for objects, such as aircraft fuselages, which do not readily lend themselves to the installation of attachment points. The most desirable method of rigging this type of object is through the use of rope, cable, or strap type lifting harnesses to provide a choke hold on the object to be recovered. Difficulty arises in this task when the object to be recovered is buried in mud or sand; the lift sling assembly was developed to alleviate this problem.

- a. Ability to pass a 6-inch-wide x 1/8-inch-thick synthetic sling at a minimum rate of six inches per minute around an eight-foot diameter object which is resting half buried in a mud bottom.
- b. Operable by the Work Systems Package with jetting water provided by the variable ballast pump of the PIV.

Figure 12. Lift sling emplacement device (15 3/4 feet long, 10-foot diameter semicircle).
(LRO 4271-9-79B)

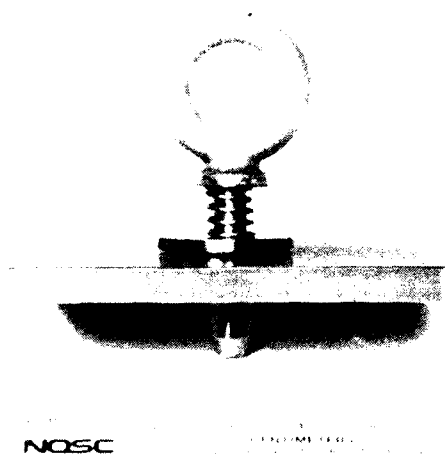
Toggle — The Toggle Bolt padeye (Figure 15) was developed as a method of quickly and easily installing lifting points for sea-floor recovery operations. Current methods of recovering large, plate-like structures consist of using slings, grapples, or nets to capture the object to be recovered. These techniques are cumbersome, slow and frequently ineffective.

The primary advantages of the toggle bolt padeye include easy installation, small size, and high lifting strength with a small through-hole requirement. The prototype has been tested to 4,700 pounds with a through-hole of 3/4-inch diameter. This is achieved primarily through the unique eccentric configuration of the unit. A relatively large load bearing area is available through the grip plug configuration. The toggle bolt is easily installed by the WSP manipulator into a predrilled hole and once locked the entire assembly rotates as a unit and the bearing surface is preserved for all orientations of the eye.

Figure 15. Toggle Bolt padeye.
(LRO 2686-6 79B)

A total of two toggle bolt padeyes were successfully inserted and locked into position on the steel plate. Due to delays in diver support and approaching darkness, a lift test of the object was not conducted. Appendix H details observations made during SCI testing.

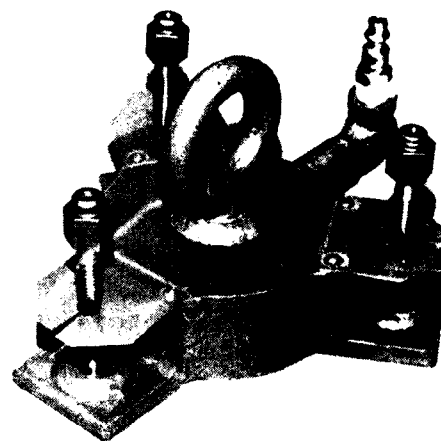
Figure 16. Drill-Tap-Bolt padeye.

Drill-Tap-Bolt Padeye — The Drill-Tap-Bolt (DTB) padeye (Figure 16) was developed as an improved method of providing an attachment point for the installation of lift lines on an object which has an external structure or framework of sufficient thickness and strength for drilling, threading and bolting. The installation of an attachment bolt under water using existing technology is a difficult task. The manipulator operator must insert a drill bit into the manipulator-held power tool, move to the object, and drill the required hole(s). Next he must move back to the toolbox, remove the drill bit, insert a tap in the tool, move back to the work site and tap the hole without jamming or breaking the tap in the drilled hole. The tap must then be backed out, the tool moved back to the toolbox, the tap removed, and a bolt-running attachment placed on the tool. Finally, a bolt must be installed in the bolt-running attachment and moved back to the work site where the bolt is placed in the hole and

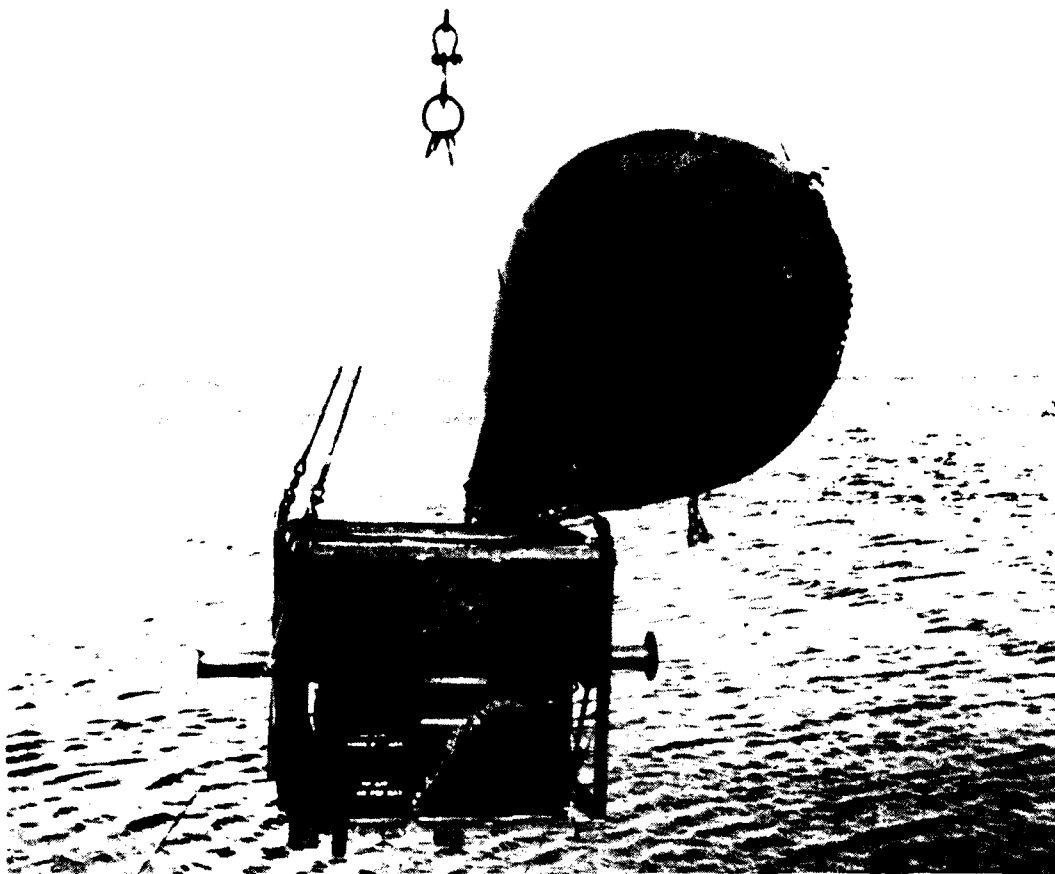
Lift Module (LM) —The Lift Module (Figure 17) was developed to demonstrate the feasibility of utilizing a fixed displacement lift bag with a self-contained gas source as a means of transporting an object from the ocean bottom to the surface. This method eliminates the unreasonably high power requirements which would be required to lift a 10,000-pound object using vehicle thruster power.

Figure 17. Lift Module being recovered after test.
(LRO 4232-9-79)

The Lift Module used at SCI is a submersible system with the lifting force provided by a 150-cubic foot, air filled, fixed displacement KEVLAR lift bag*. Initially, the lift bag is pumped full of water by a hydraulically driven pump which is under WSP control thus converting it into a "rigid pontoon." This constant bag volume is maintained by a relief valve which keeps the internal bag pressure at 5 to 10 psi over ambient pressure. Buoyancy can be varied by forcing ballast water or air into or out of the lift bag while still under WSP control. When the lift bag buoyancy is sufficient to achieve lift off, ascent is controlled by a microprocessor unit aboard the Lift Module. Control over the ascent rate is required to ensure that the dynamic load is maintained within 10 percent of the static load, and so the venting capacity of the relief valve is not exceeded.

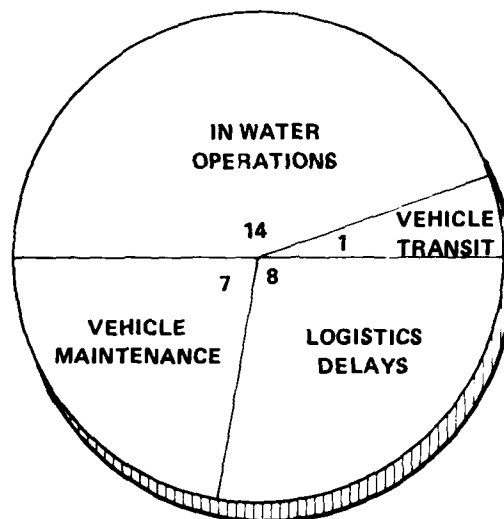
During the 30 days of testing just summarized, 14 dives were made with the vehicle which accumulated a total of 58 hours, 13 minutes of in-water time. Of the remaining 16 days, seven were required for routine maintenance or repair while nine were lost for various reasons (Figure 18). This time breakdown is typical of what can be expected when testing newly developed or integrated equipment/systems at sea for the first time. The operating experience gained with the vehicle/work system and the substantial amount of photographic documentation acquired have greatly enhanced the success of this test series. Appendix B provides a detailed listing of system problems encountered during testing.

Figure 18. SCI testing time breakdown (days).

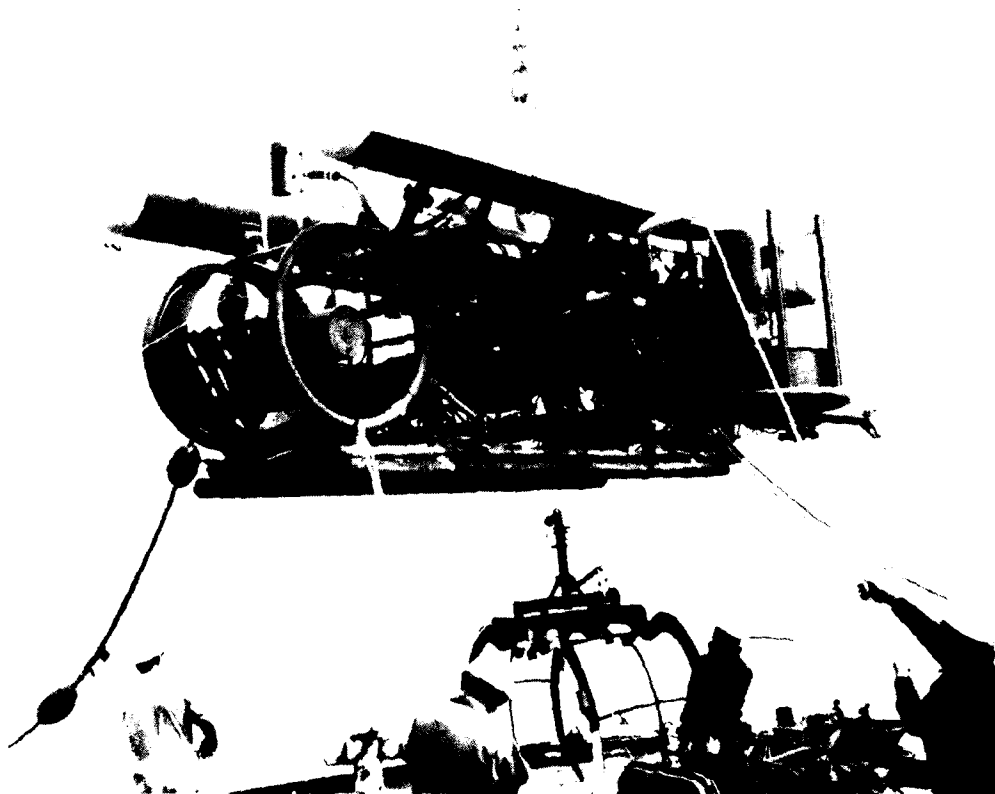
Figure C 1. Mating of claw assembly with PIV.
(LRO 3530-8-79B)

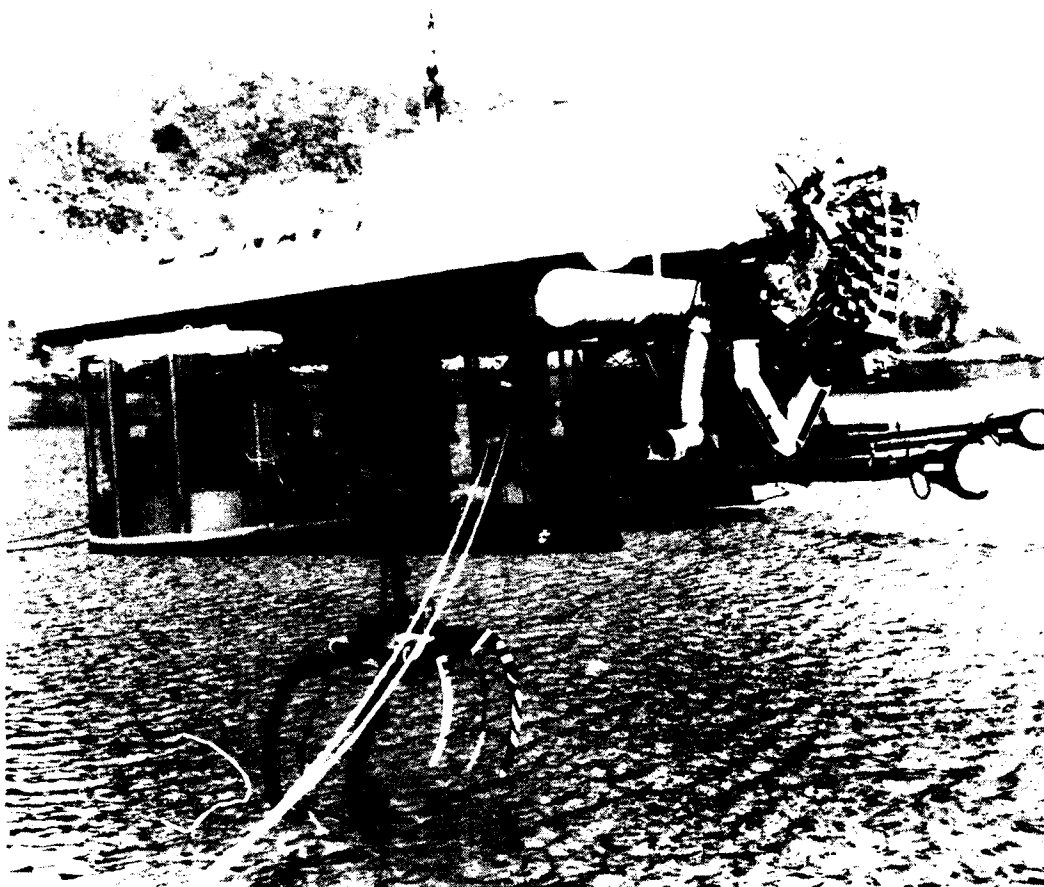
Figure C-2. WSP/PIV launch with claw assembly attached.
(LRO 3536-8-79B)

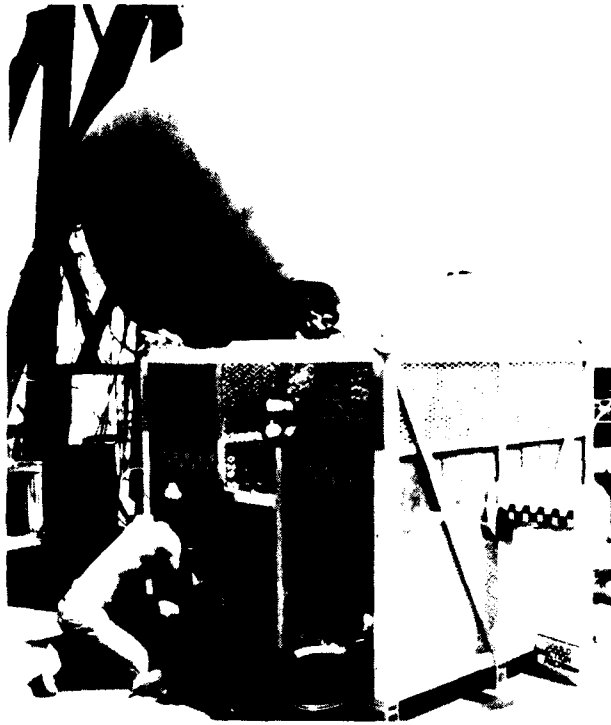
Figure D-1. Lift Module.
(LRO 3416-8-79)

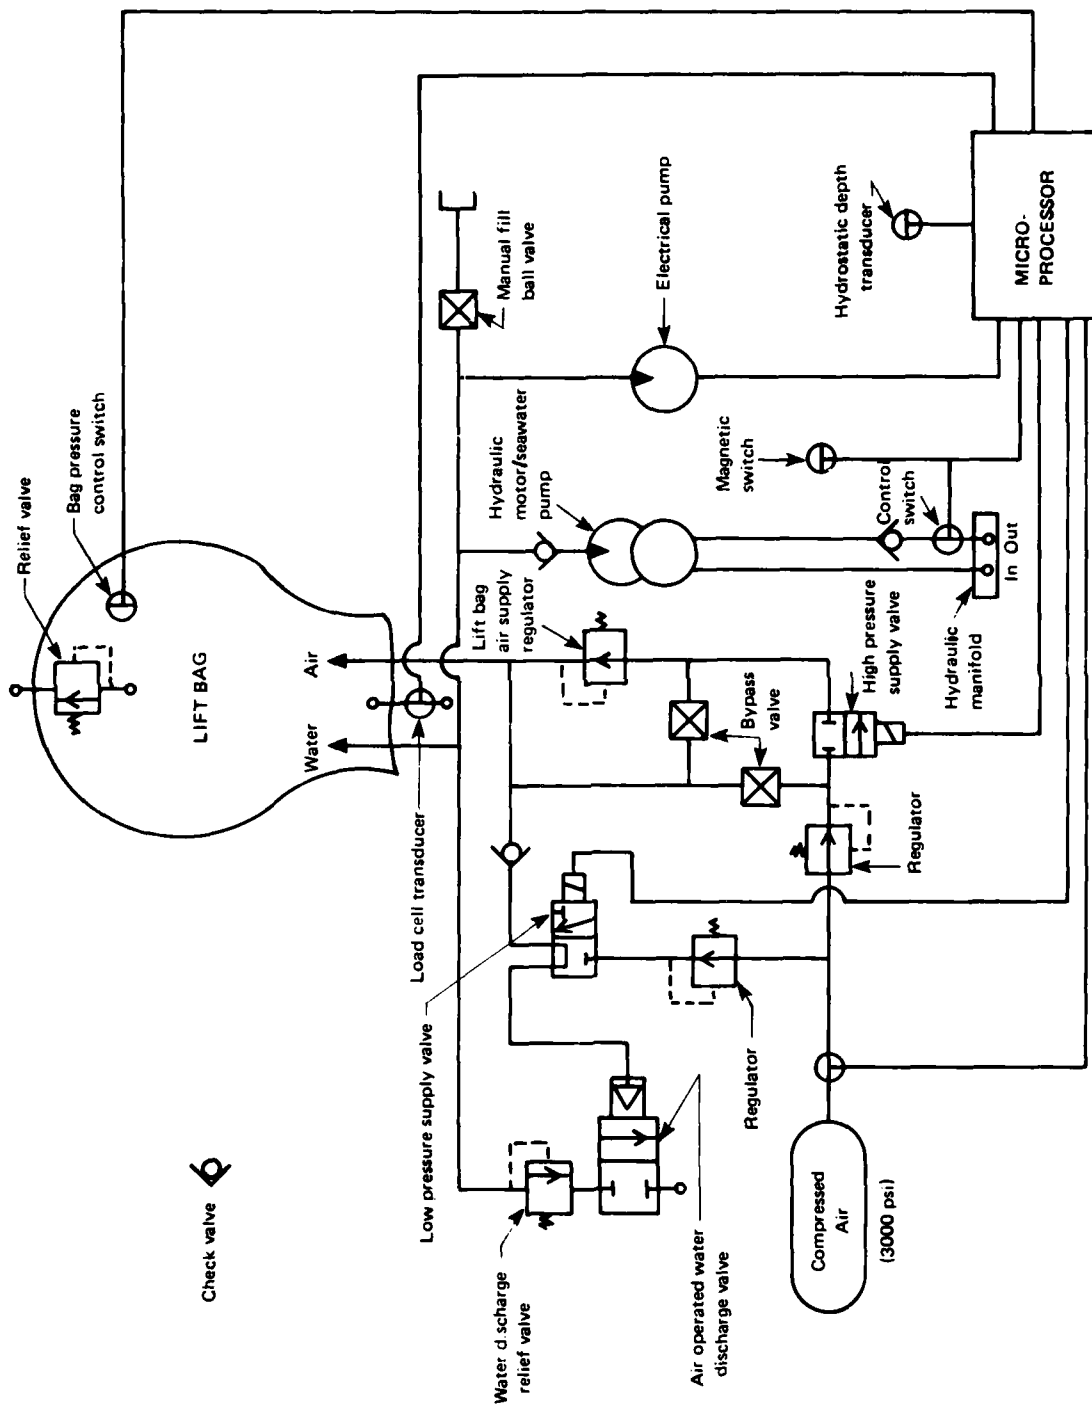
Figure D-3. Lift Module control system diagram.

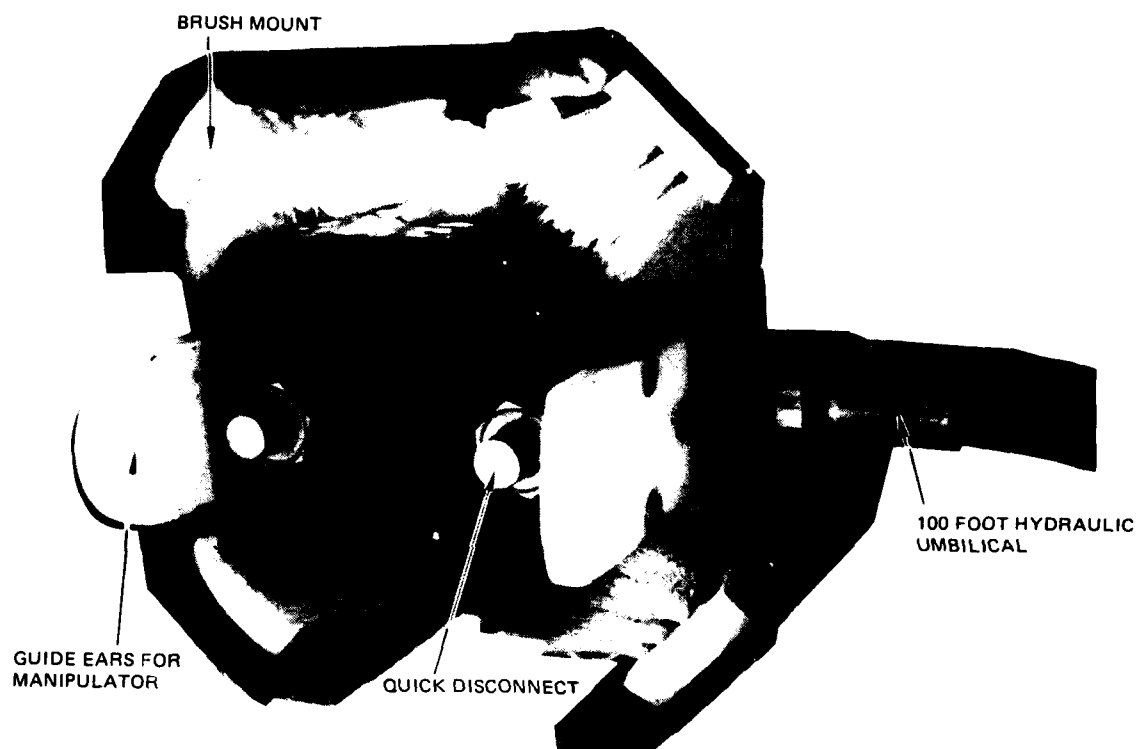
Figure D-4. Lift Module hydraulic manifold.
(LRO 5550-11-79)

2. During remote operation of the LM, the WSP operator does not have good visual contact with of the lift module. Therefore, a remote, visual display of system status located on the side of the hydraulic manifold would be appropriate. Better camera placement allowing overall viewing at the lift bag would also be desirable.
3. Feedback data to the WSP operator should include either a load cell readout or indication of water level within the lift bag (ie, sight glass arrangement).

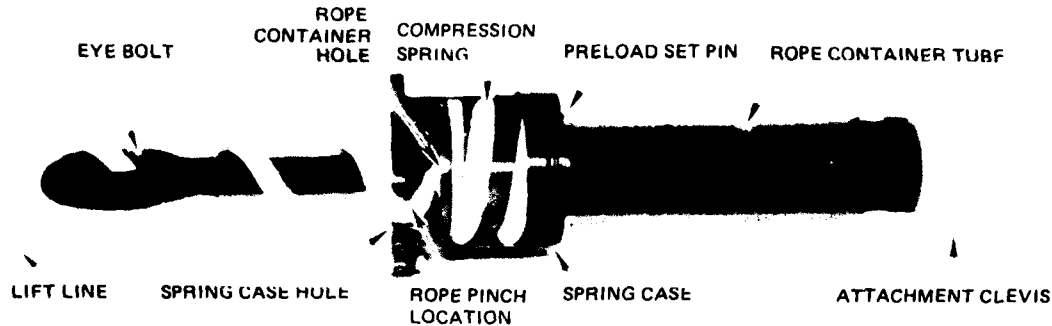
Figure E-2. Attachment Arm/Tension Limiter Assembly. (Sectioned View)
(LRO 1360-4-80B)

limit and begin to pay out line. Depending on the weight distribution on the object, three of the four tension limiter assemblies may have to slip to distribute the weight of the load on all four arms equally. At this point lift can be achieved.

The RM consists of buoyancy pods encased in a steel frame equipped with a garland ring at the top as an attachment point for the lift line. Four attachment arms extend from the underside of the frame and are equipped with load attachment lines and hooks. Each rigging line consists of a snap hook and a slackout device. Once connected to the attachment point, the line can be pulled through the "cam cleats" of the slackout device to remove the excess rigging line. Final rigging adjustments are provided automatically by each arm which is configured with a tension limiter assembly (Figure E-2) that adjusts for equal distribution of the weight of the load, on all four arms, during the lift. The tension limiter resistance force can be preset by the placement of a locking pin in one of four hole positions in each arm. Each hole position represents a different predetermined resistive force that the attachment line must exceed before it begins to slip. As the lift is begun, the attachment arm on the heavy side of the recovery object will reach its predetermined load

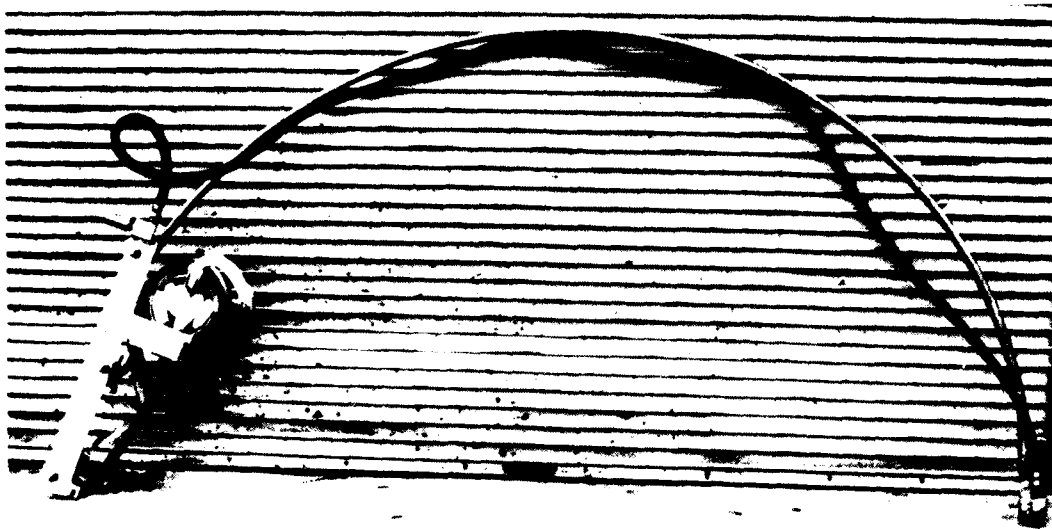
Figure F-1. Lift sling emplacement device.

The lift sling emplacement device (Figure F-1) provides a lift method for objects, such as aircraft fuselages, which do not readily lend themselves to the installation of attachment points. This method of rigging utilizes a strap type lifting harness to provide the choke hold on the object being recovered. Difficulty arises in this task when the object to be recovered is buried in mud or sand; the lift sling assembly is intended to alleviate this problem.

The lift sling assembly consists of curved steel jetting tube supported and guided by three rollers mounted to a support frame with a 10-foot diameter semicircle (Figures F-1 and F-2). A wedge-shaped nozzle is located at one end along with provisions for attaching one loop of the synthetic sling. A 3/4-inch inside diameter hose supplies water to the opposite end of the jetting tube. The jetting tube support bracket has provisions for a quick disconnect fitting for the jetting water line (Figure F-3). A bracket was added to the female fitting of the quick disconnect to allow for holding with the manipulator of the WSP. During development it was decided that the optimum nozzle configuration was one with a small flow divider. With this nozzle configuration it was found that it was possible to advance the jetting tube and sling through the soil and if the tube stalled, waiting 20 to 30 seconds would allow the jetting water to fluidize the soil to a point where the jetting tube could be advanced further. The jetting tube support bracket has provisions for storage of the sling and choker cable, snap hook, and for grasping of the bracket with the WSP grabber arm (Figure F-4).

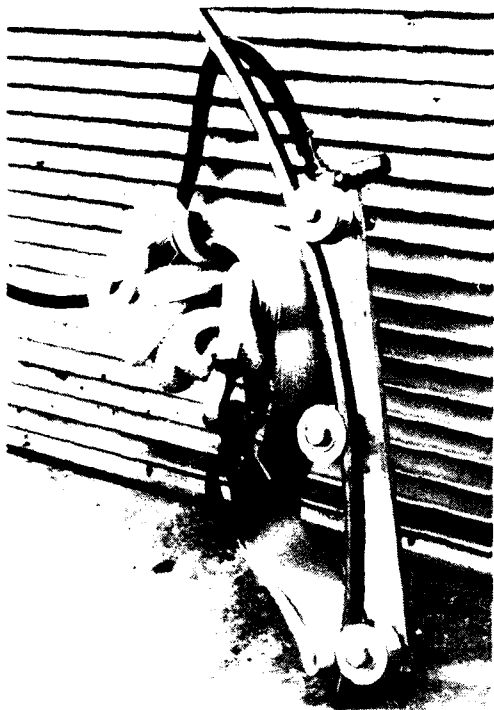
Figure F-2. Jetting tube support bracket.

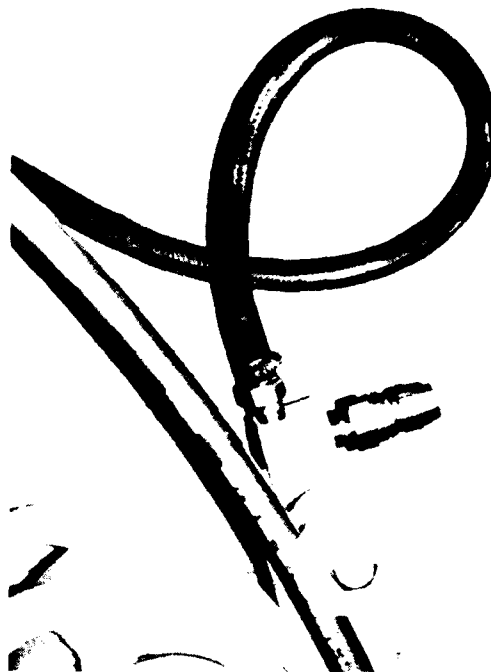
Figure F-3. Jetting hose connections to jetting tube support bracket.

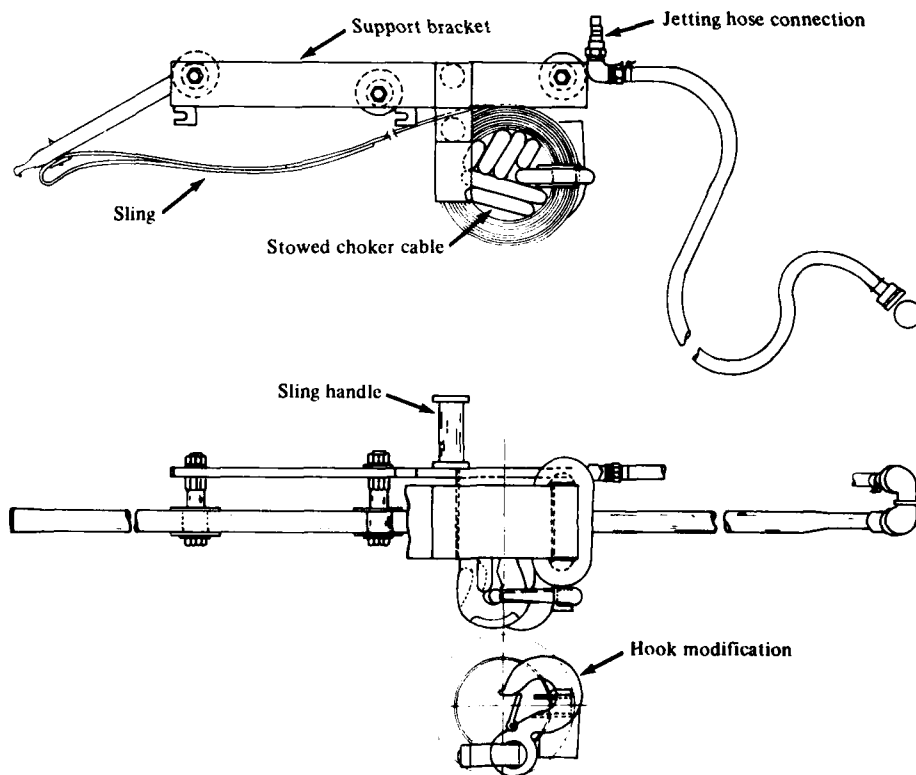
Figure F-5. Lift sling detail.

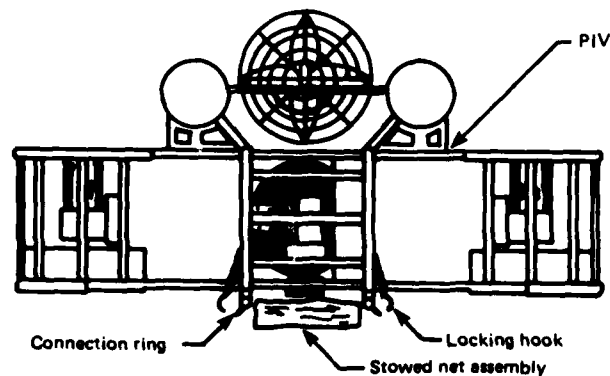
Figure G-1. Net assembly (stowed position) installed on the PIV.

The net assembly developed consists of a unit which in its stowed position measures only 4 feet wide by 20 feet long. When fully deployed the net is 20 feet by 20 feet. The net assembly frame is constructed with side members of two-inch diameter fire hose and corners made of pipe elbows and nipples connected to the fire hose. The PIV was modified with the installation of hydraulically actuated release shafts to its undercarriage. These shafts have hooks for holding of the net assembly during transit to the recovery site. A retaining canvas, with connection rings, is placed under the net assembly (in the stowed position) and then placed under the PIV (Figure G-1). The connection rings are attached to the hooks of the hydraulically actuated shafts and locked into place. The vehicle is then launched for transit.

Once at the recovery site the shafts are hydraulically actuated to release the net assembly. The vehicle is then backed off from its position over the net while laying out the fill hose. The fill hose is connected to the fire hose side member and has a quick disconnect at the WSP. Deployment of the net assembly is accomplished by filling the fire hose with sea water causing the net to unfold and the side members to become rigid (Figure G-2). Filling is achieved through use of a sea water pump powered by the WSP-operated drill motor. A pressure regulator in the system insures that the hose is not pressurized above 100 psi. When the net is fully deployed, the WSP manipulator is used to release the quick disconnect. The recovered object is then placed in the net. Each corner of the net has a connection line and ring for hookup to a single lift point. Lifting of the net and recovered object can then be accomplished through the use of the Lift Module or by PIV thruster power.

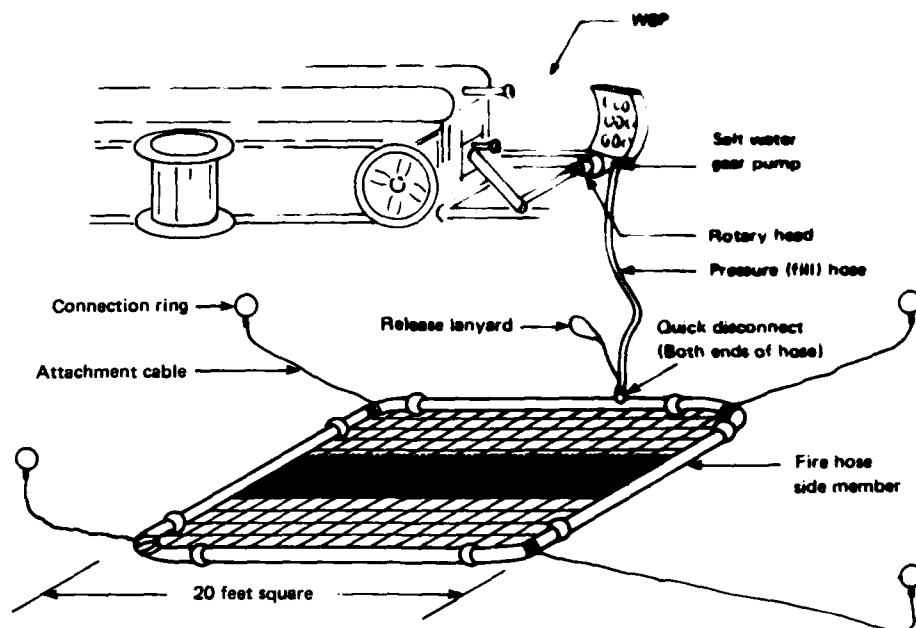
Figure G-2. Net assembly in the deployed position.

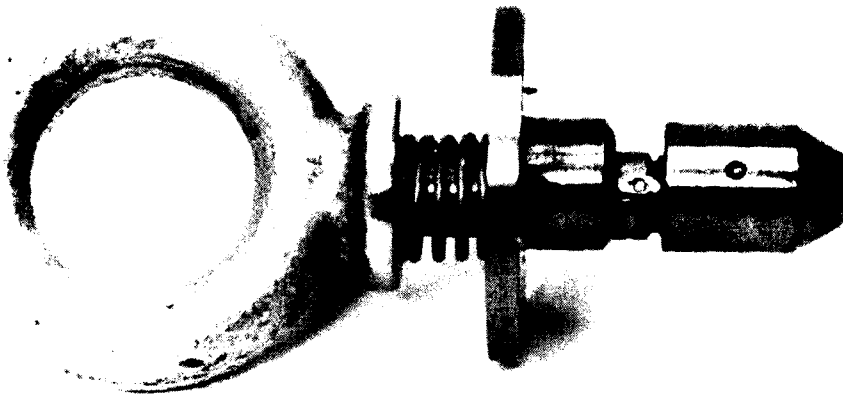
Figure H-1. Toggle bolt padeye in the cocked position for insertion.
(LRO 2687-6-79B)

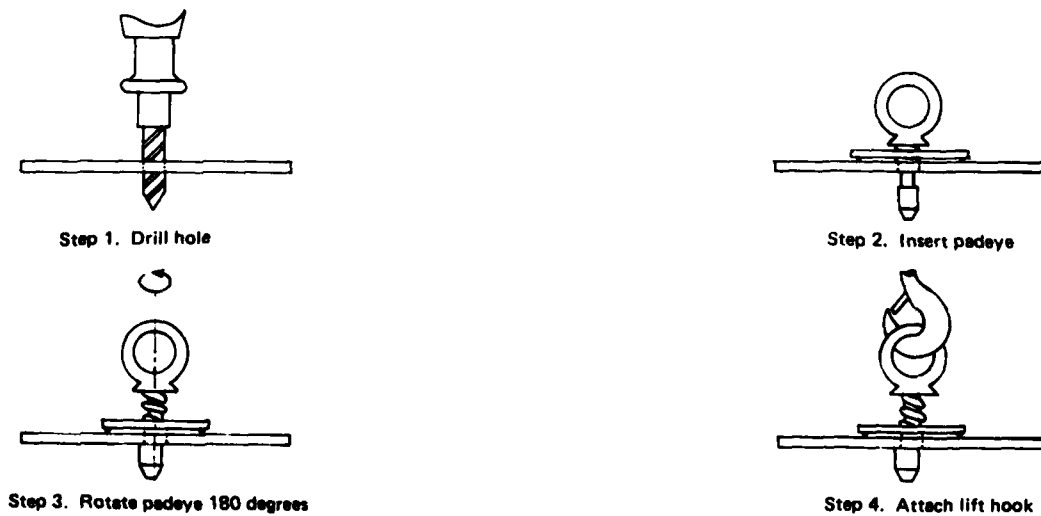
Figure H-2. Procedure for installing toggle bolt padeye.

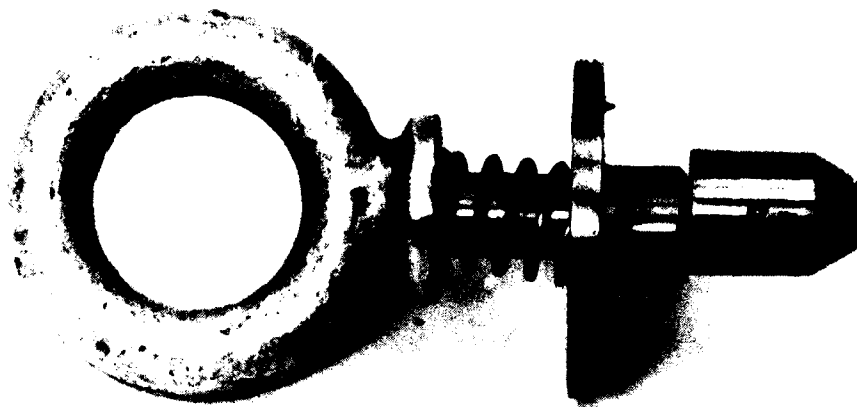
Figure H-3. Toggle bolt padeye in the deployed position.
(LRO 2688-6-79B)

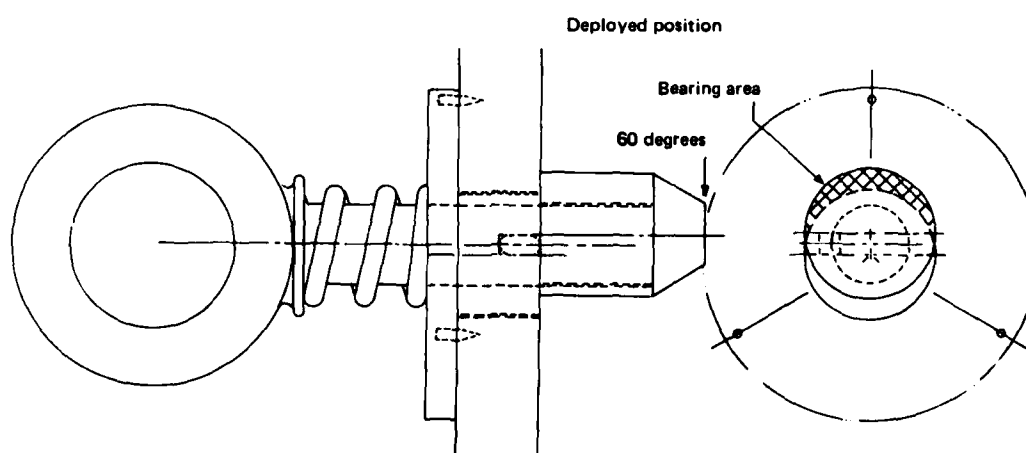
Figure H-4. Deployed toggle bolt padeye showing bearing area.

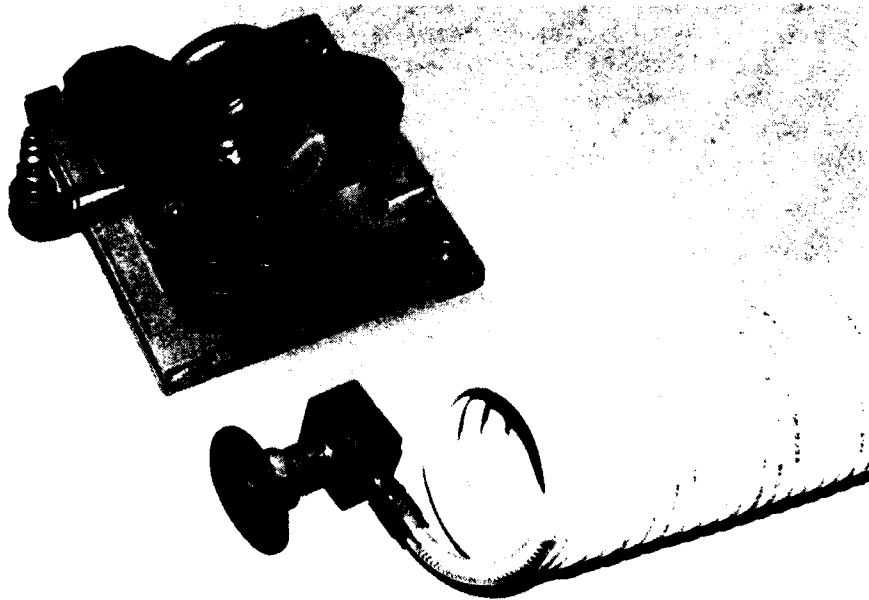
Figure I-1a. DTB padeye mounted in its holding plate and the suction hose and quick disconnect fitting.

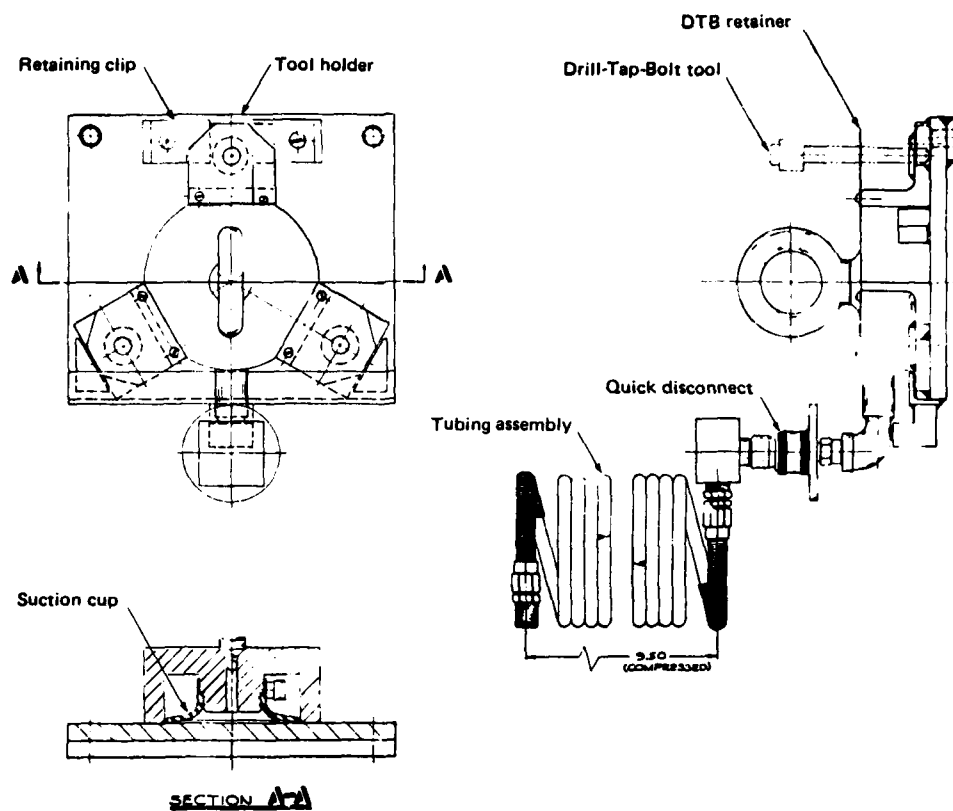
Figure I-1b. DTB schematic.

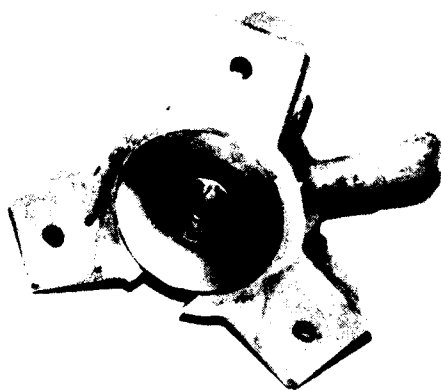
Figure I-2. DTB padeye, bottom view.
